*Airfield Damage Repair Modernization Program*

## **AM2 Brickwork Pattern Evaluation with Refurbished Matting**

Lyan Garcia, Timothy W. Rushing, and Jeb S. Tingle

August 2015

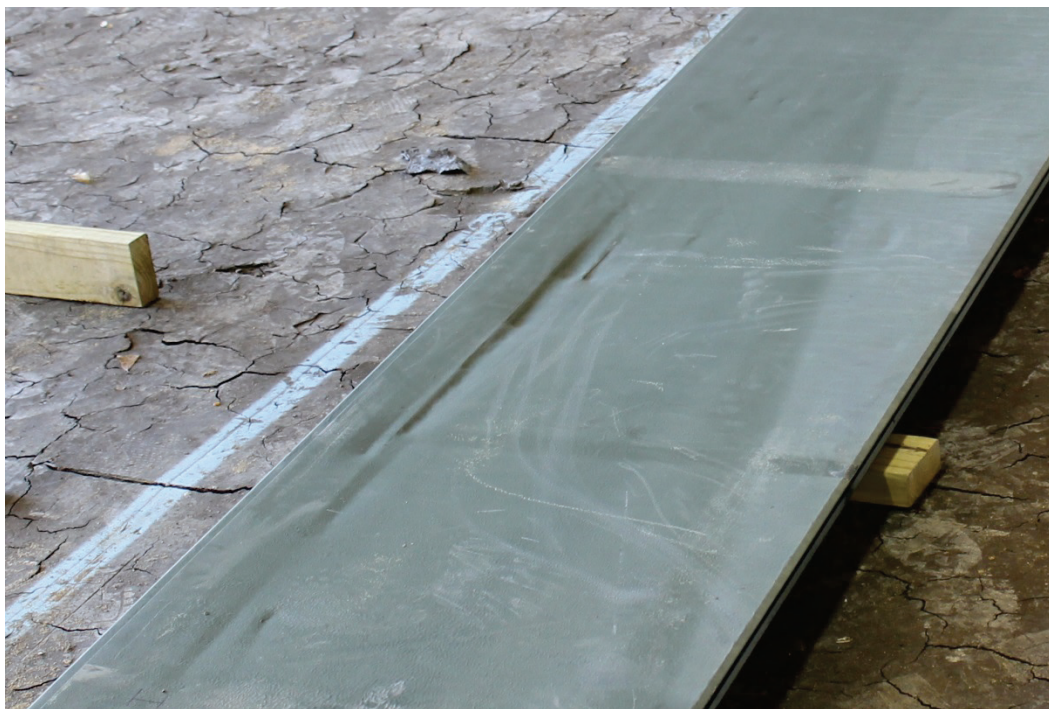
Figure 2. Damage noted on refurbished AM2 panel before applying traffic.

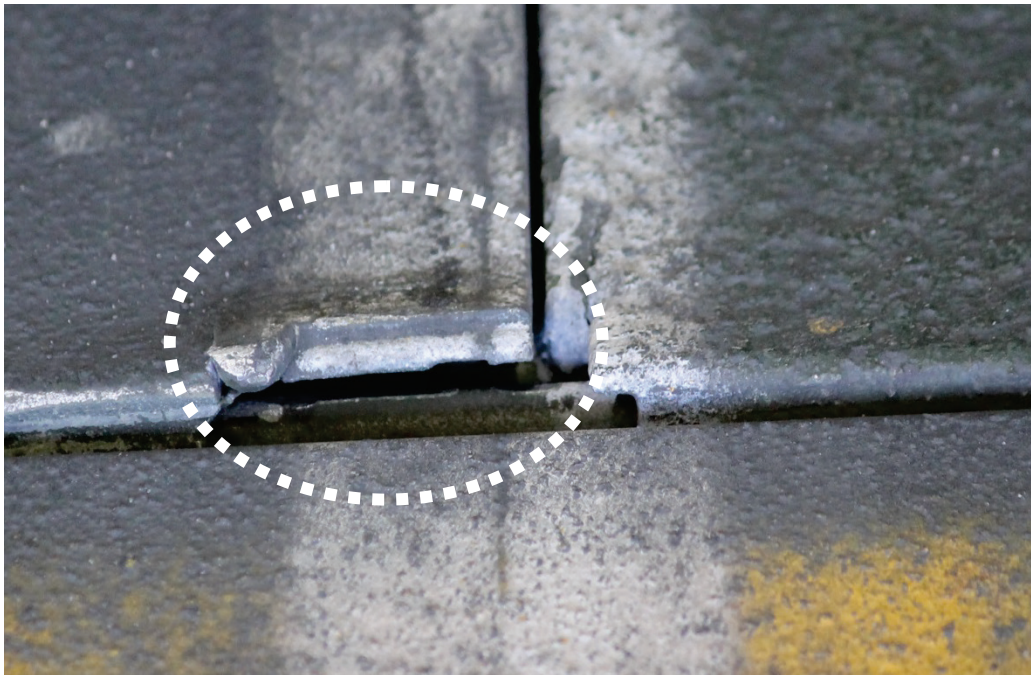
Figure 41. Corner curl in Panel 26 after 240 passes.

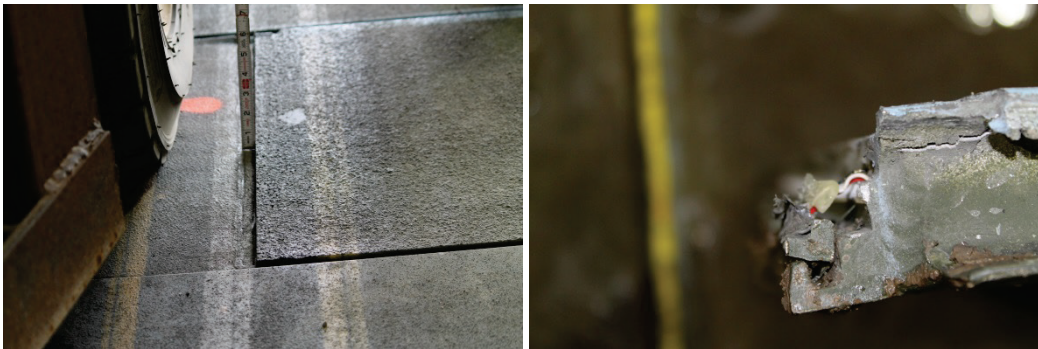
Figure 42. Broken upper under lap rail in Panel B40-1.

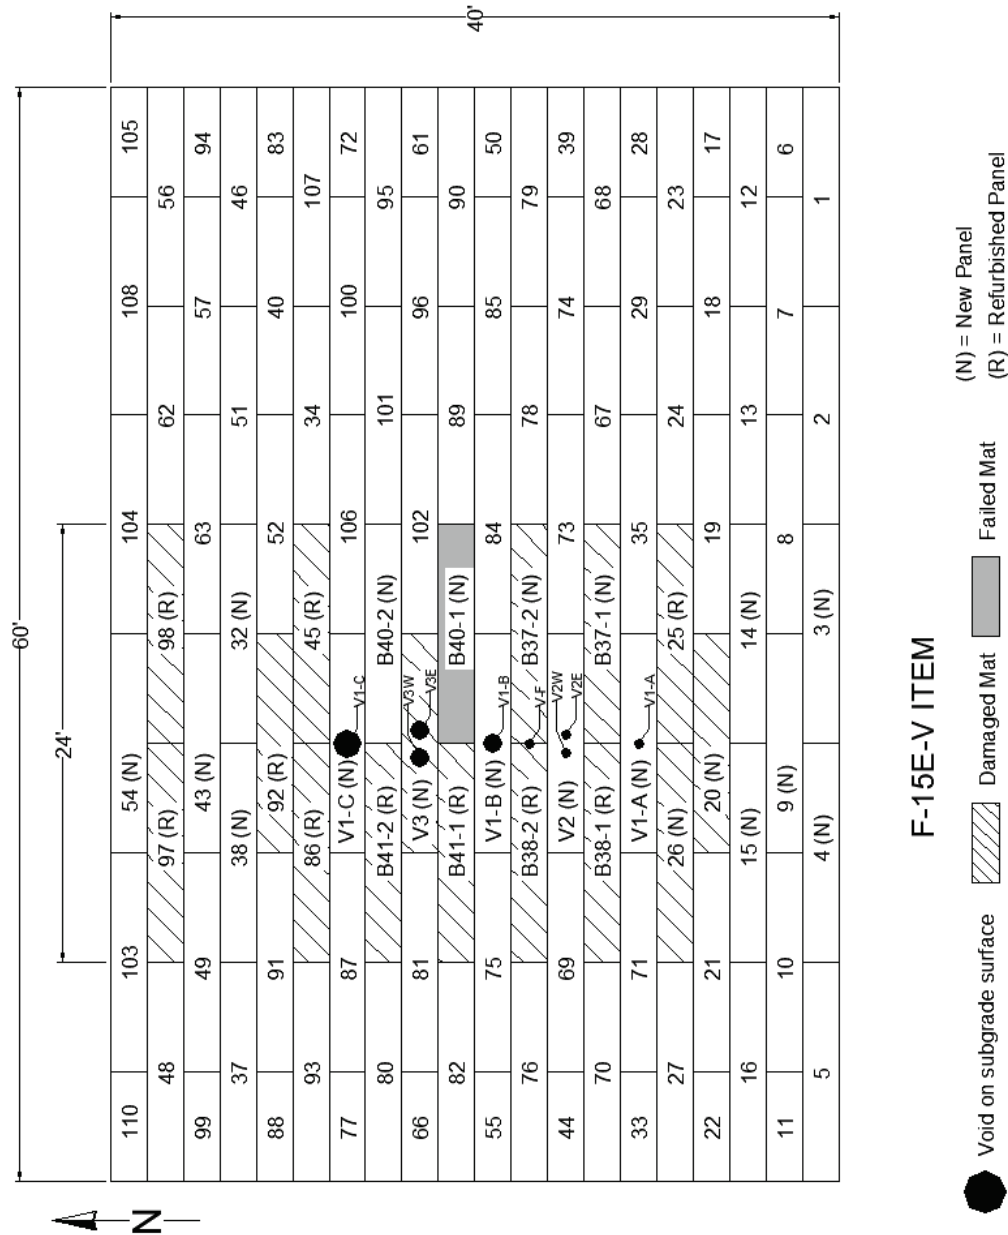
Figure 44. Layout of damaged and failed panels in the F-15E-V item.

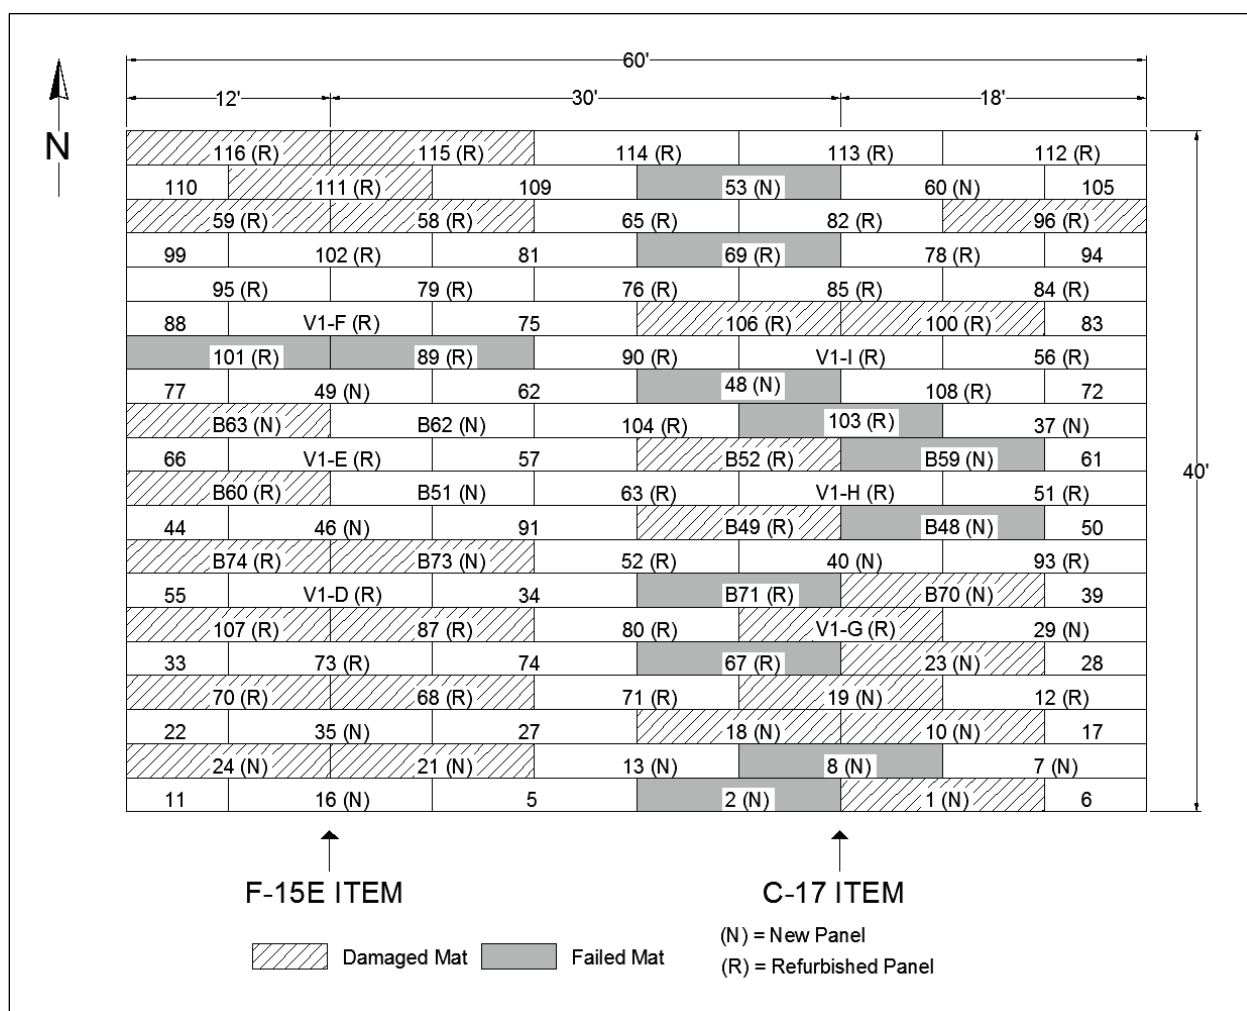
Figure 64. Layout of failed and damaged panels in F-15E and C-17 items.

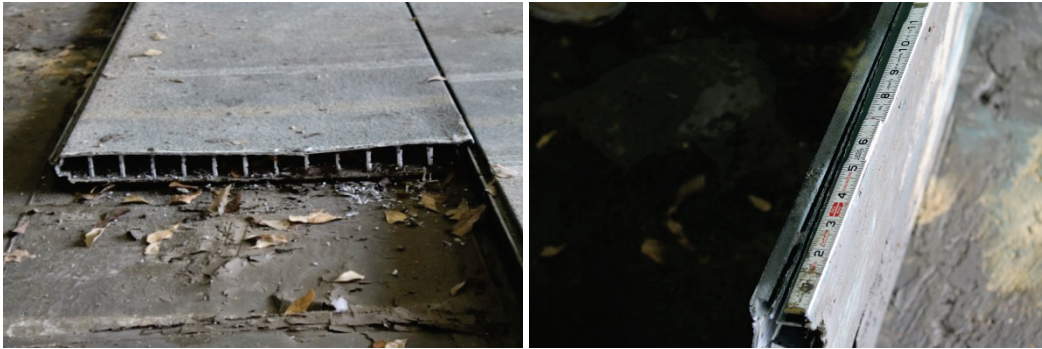
Figure 65. Panel 89 after 430 passes.

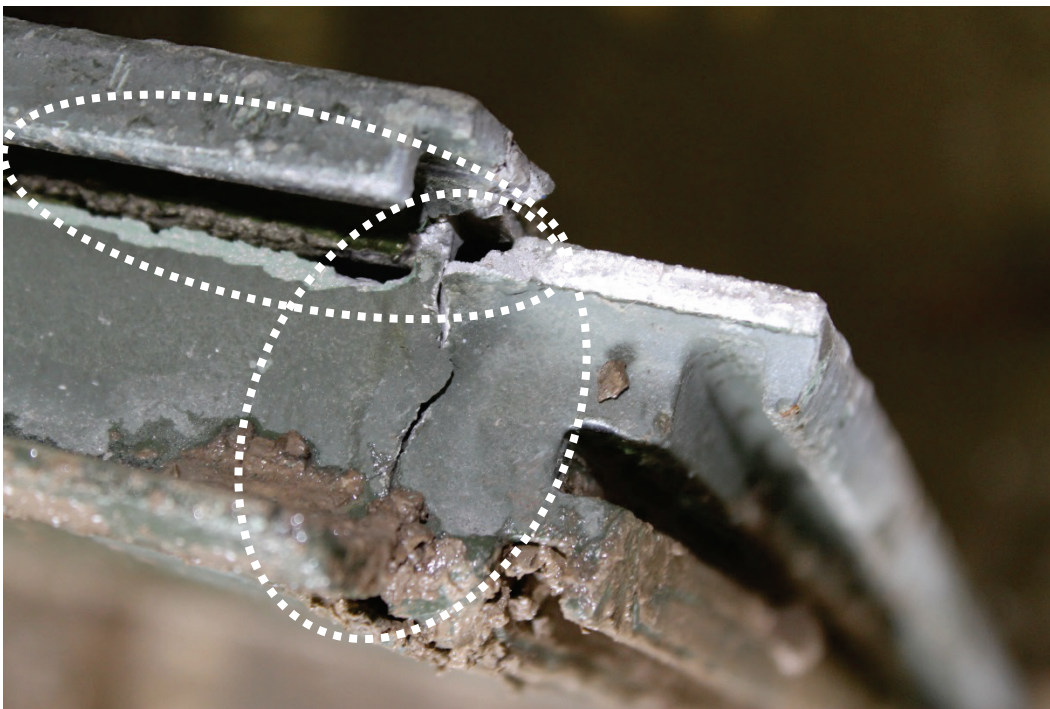
Figure 66. Damage noted in Panel 101 after removing from test section.

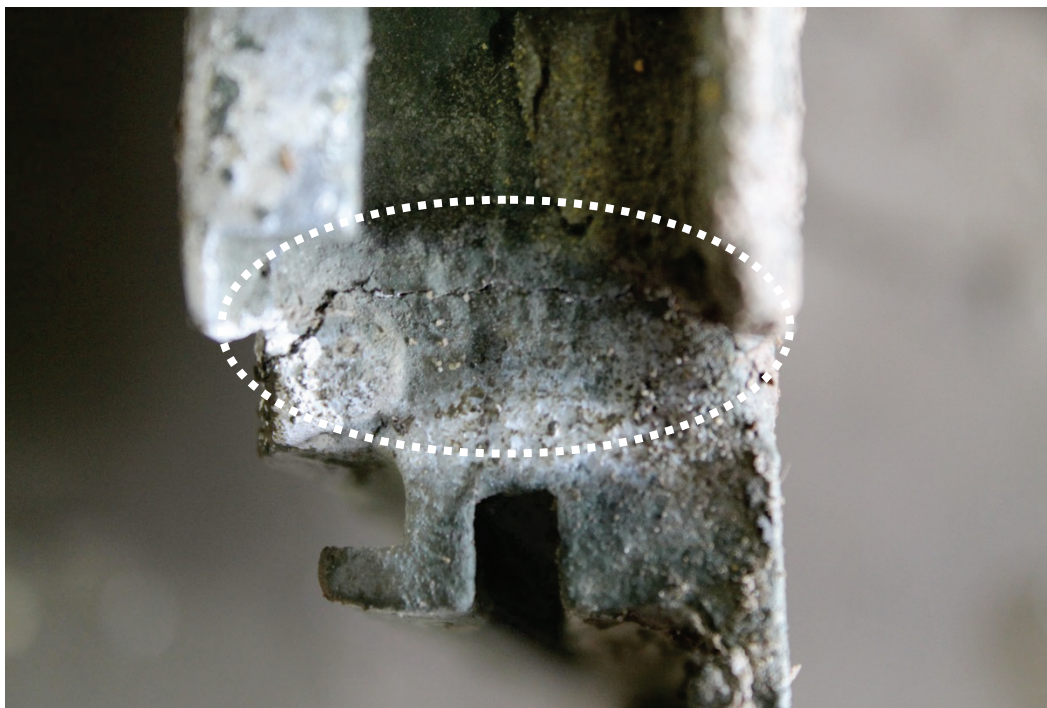
Figure 67. Damage noted in Panel 68 after removing from test section.

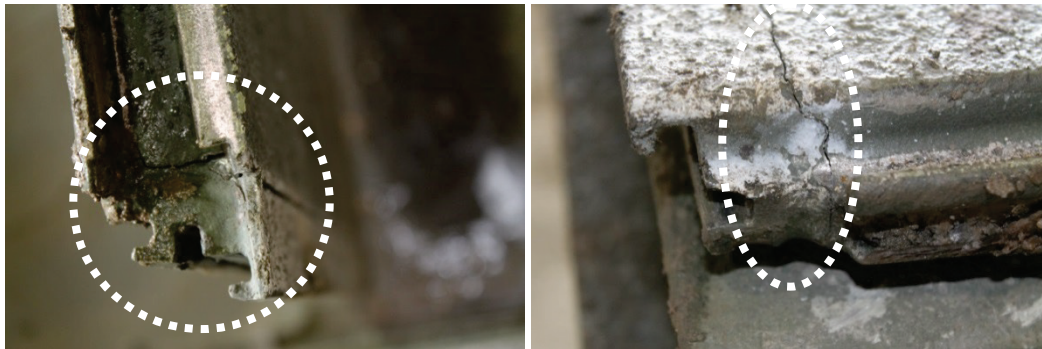
Figure 68. Panel 69 after removing from test section.

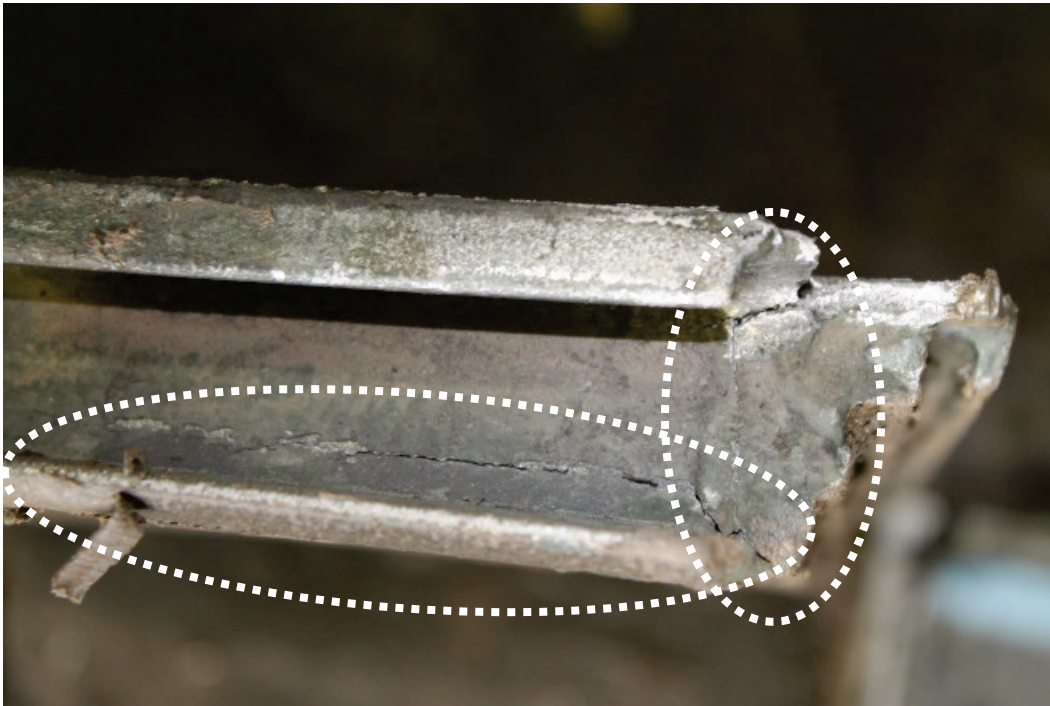
After 1,162 passes, the length of the crack on Panel 103 increased to 40 in. Panels B59 and B70 were noted to have 0.13-in. corner curls on the southeast corner of each panel. Panel B49 had a 1.5-in.-long crack along the weld of the overlap end connector. Panel 67 developed a top skin tear along the top flange of the female hinge that was 1.5 in. long. The corner curls in Panels 67 and 23 increased to 0.19 in.

Figure 69. Panel 67 after 1,308 passes.

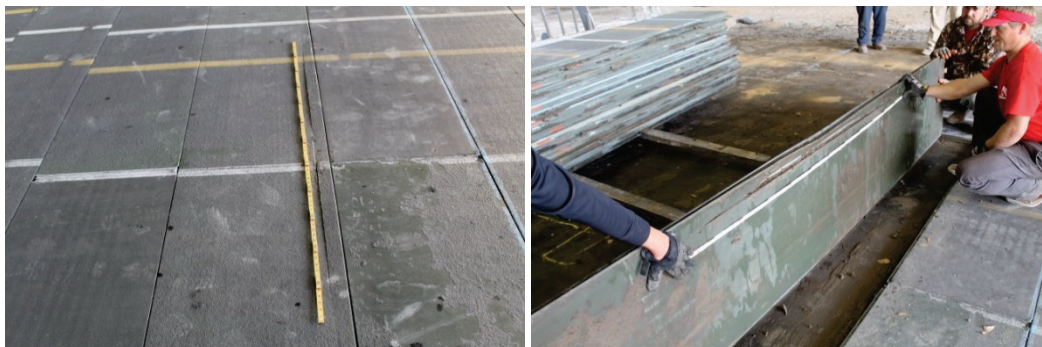
Figure 70. Damage in Panel 103.

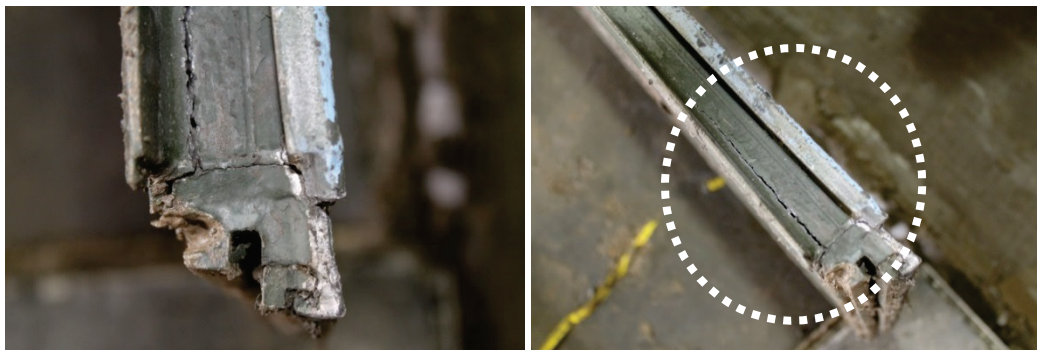
Figure 71. Panel B52 after removing from C-17 test item.
